# White Paper 4

## Understanding Electrical Overstress - EOS

### Industry Council on ESD Target Levels

Revision 1.0

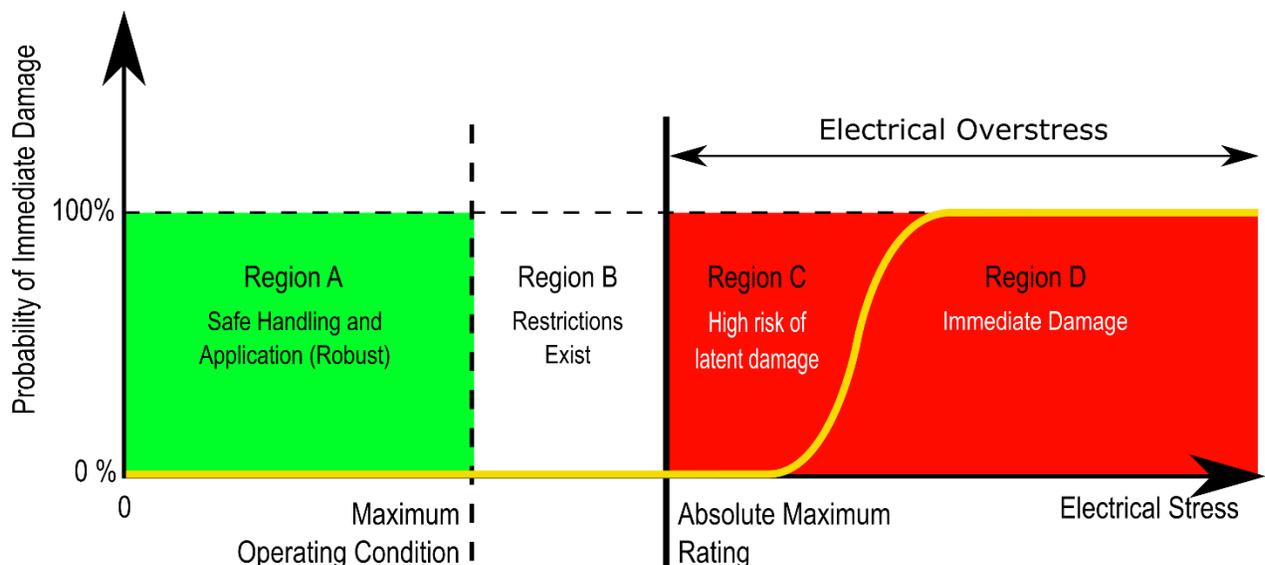
Figure 1: A graphical depiction of how Absolute Maximum Ratings should be interpreted. The yellow line is the number of components suffering immediate, catastrophic EOS damage

First, there is the safe operating area, a region of robust operation (region A). This is the region in which the manufacturer designed the device to operate. This is followed by a region in which operating restrictions exist (region B). In region B, the device is not expected to fail but there may be functional issues due to operation outside of the device's designed voltage range. Operating the device in region B for extended periods of time may also result in reliability issues. The upper limit of region B is the AMR. At and beyond the AMR the user should expect problems. Beyond the AMR are two regions of *electrical overstress* with either latent (region C) or immediate (region D) damage as a result of exceeding AMR. Note that the transition between latent damage and immediate damage is subject to normal process variations as illustrated by the yellow S curve.

There are different methods a device manufacturer may use to determine AMR values. The manufacturer may pick very conservative AMR values not based on physical properties of the product. This results in a wide region C before the onset of immediate damage. Alternatively, the manufacturer may define the AMR values based on detailed circuit and technology understanding resulting in a more accurate prediction of the damage threshold. This can result in the near elimination of region C. Regardless of the method chosen, the manufacturer is solely responsible for defining the AMR. Further, an AMR is a function of stress duration and any single documented value will have a fixed time association. Consequently, a clear understanding of the AMR by a system manufacturer is necessary to ensure that the operating environment of the system is within the specified conditions and that the limits defined in the AMR are never exceeded. This is particularly important when the system is using the semiconductor device in new or unique configurations. In these special cases, communication between the supplier and system manufacturer is *absolutely necessary*, particularly if the AMR does not appear to cover a mode of operation the system manufacturer expects their system to experience.

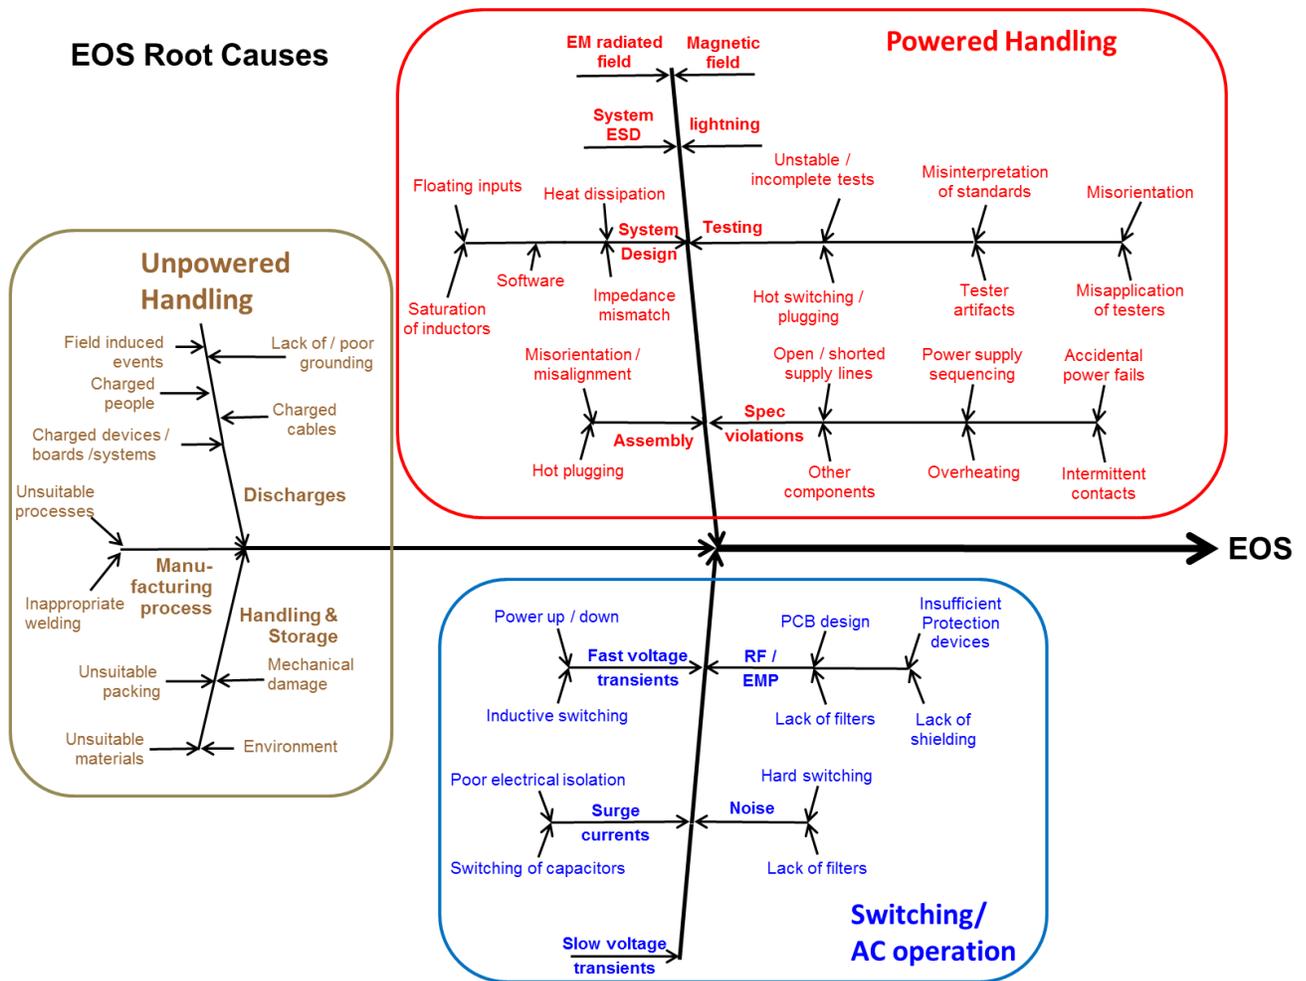
Each category can be traced to a specific sub-category shown as branches in the fishbone diagram of Figure 2. The sub-categories of Figure 2 are not meant to be an exhaustive list of root causes but an overview of some of the more common root causes.

Figure 2: Fishbone Diagram Representing Different Root Causes Leading to EOS

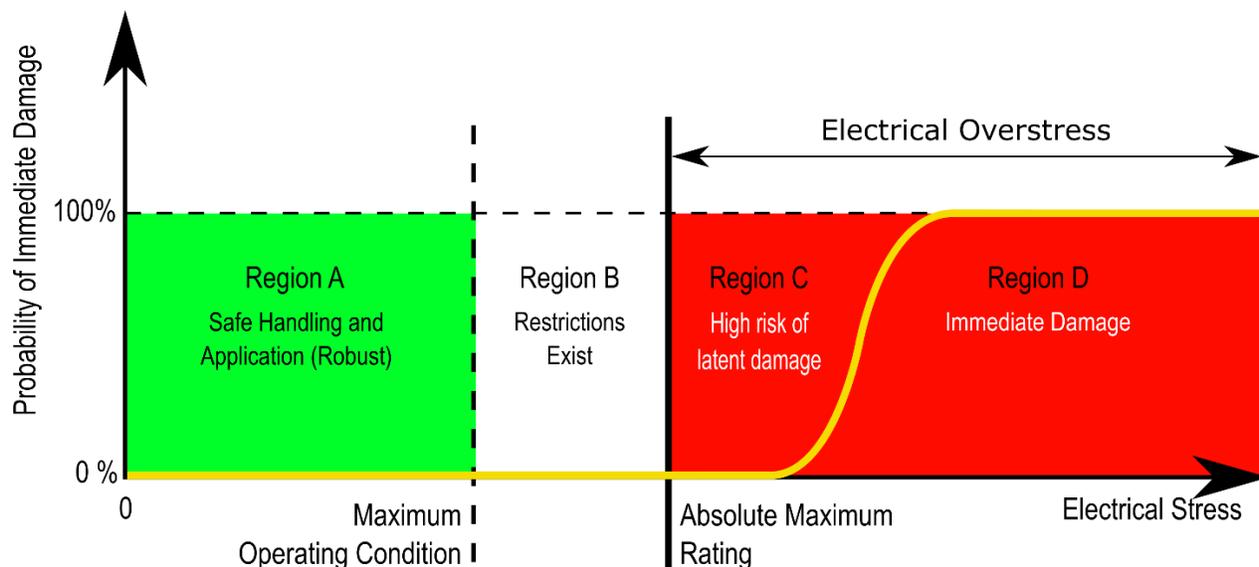
starting at the high end of region C. Regardless, a device operating in either region C or region D is experiencing EOS.

Figure 21: A graphical depiction of how Absolute Maximum Ratings should be interpreted. The yellow line is the number of components suffering immediate, catastrophic EOS damage (repeated from Figure 1).

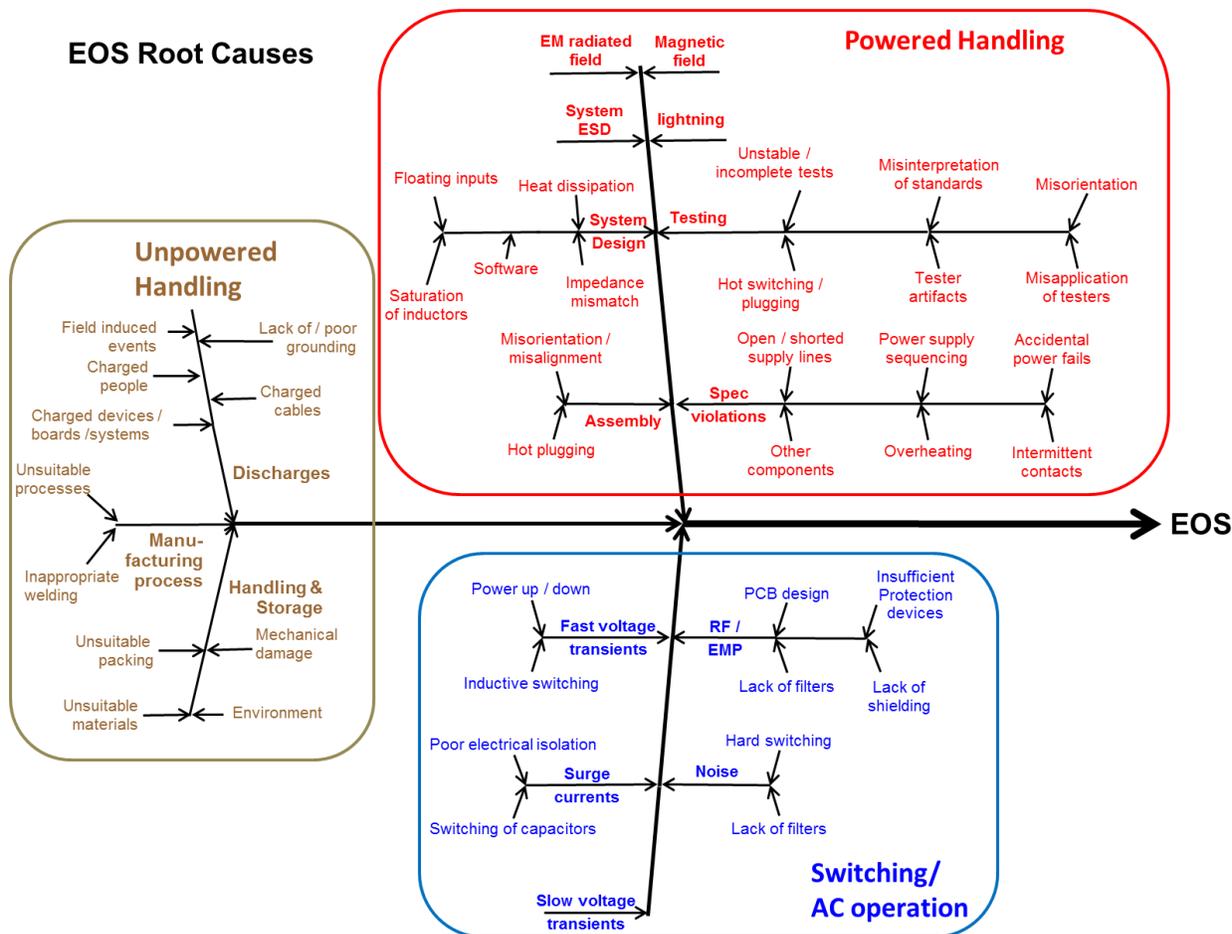
Figure 22: Fish Bone Diagram Indicating Categories and Typical Subcategories of the Root Causes for EOS Damage (the sub-categories are not an exhaustive list, repeated from Figure 2)

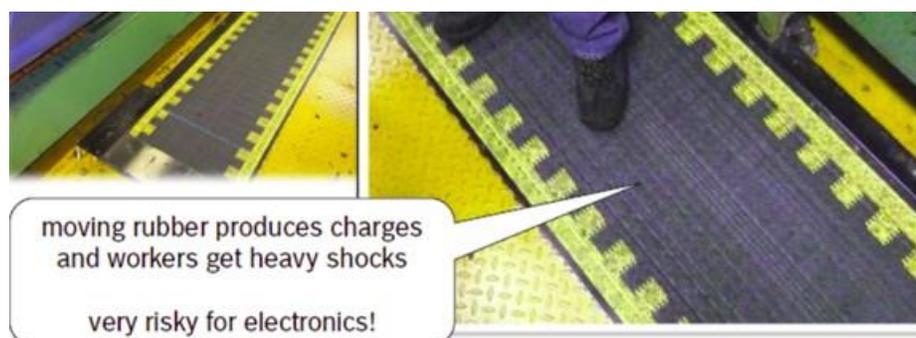
An effective ESD control program **avoids charging or fast discharging** in the assembly line. A wide range of factors have to be considered here: floor, shoes, stores, transportation boxes, system chassis, conveyors (shown in Figure 24) and plastic material assembled to the end-customer system such as in a car.

Figure 24: Conveyor ESD Risk in an Assembly Line

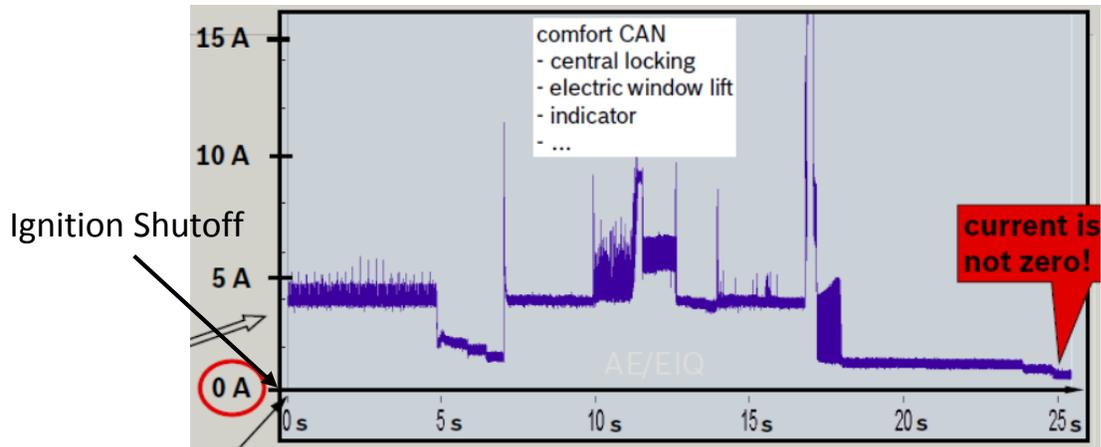
As shown in Figure 26, switching off the ignition of a car does not mean the current in the car is also off. Several applications in the car are still actively supplied directly from the battery’s positive terminal (terminal 30 as per DIN 72552). For several minutes there are amps of current, decreasing over time down to milliamperes.

Figure 26: Residual Current after Ignition Shutoff

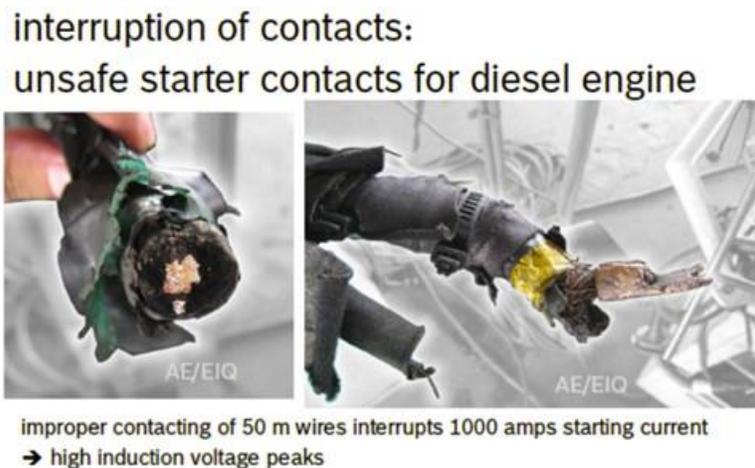
This unsafe connection caused huge starting currents to be switched off and on, generating a burst of out-of-specification induction voltage peaks. These voltage peaks destroyed the diesel injection electronics, including the heavy copper cables, see Figure 27.

Figure 27: Example of Improper Contacts during Engine Start Up

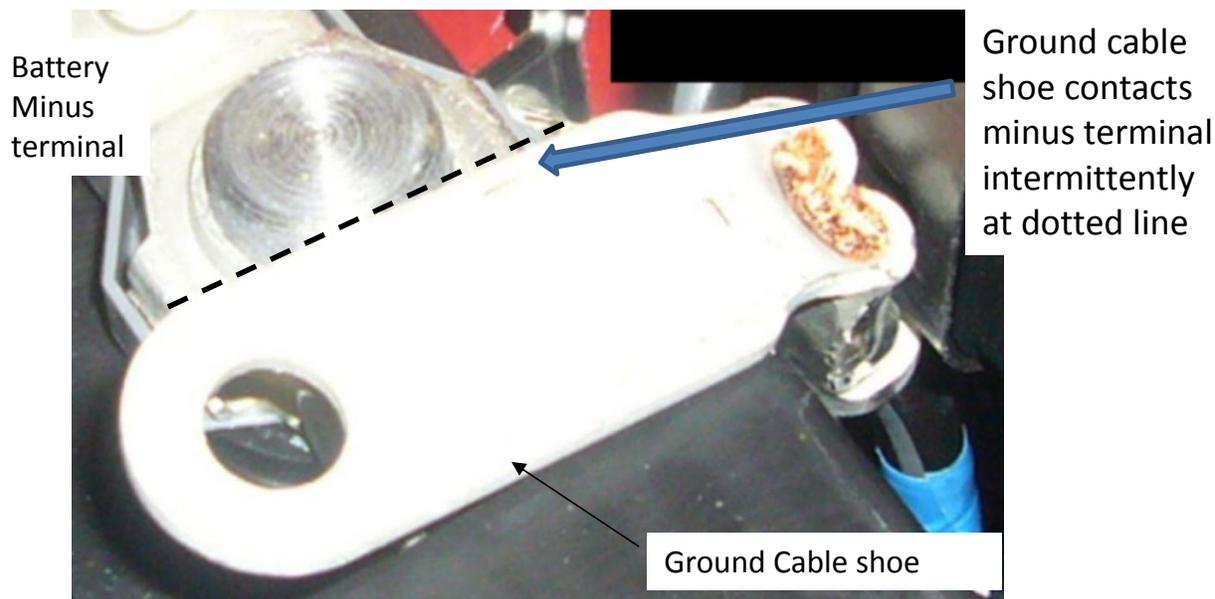
In a third example, a worker in an automotive assembly line customer installed the battery into the car. The positive pole was attached to the terminal and the negative (minus) pole was left unattached in order to keep the car unpowered. But the final ground wire from terminal to chassis was too stiff, pushing the contact shoe back to the minus terminal of battery and creating a loose contact with it as shown in Figure 28.

Figure 28: Interruption of Battery Contact during Assembly

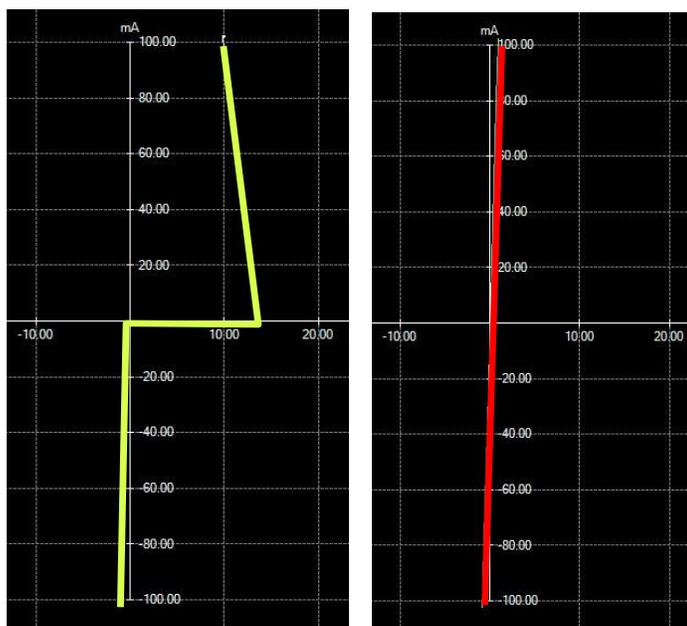
The electrical failure signature was a short of several IO pins to GND as illustrated in Figure 29.

Figure 29: Curve Trace of Good Device (left) and Damaged Device (right)

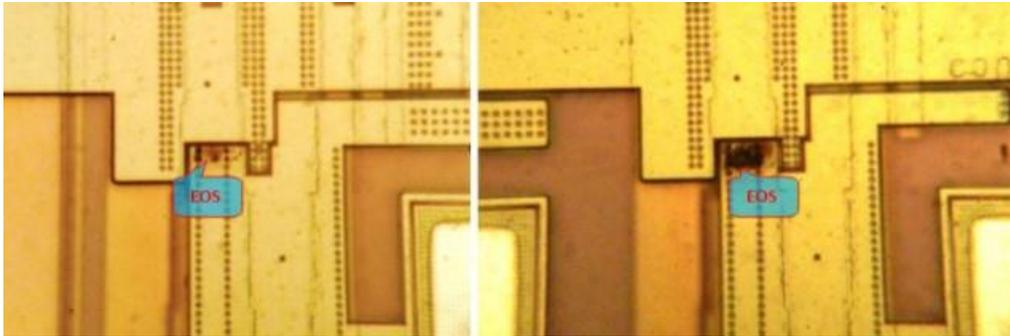
Physical analysis revealed a damaged metal trace (EIPD location) leading to the ESD protection, as depicted in Figure 30, which strengthened the customer's opinion that the device had an ESD weakness.

Figure 30: Optical Photo of Damaged Devices

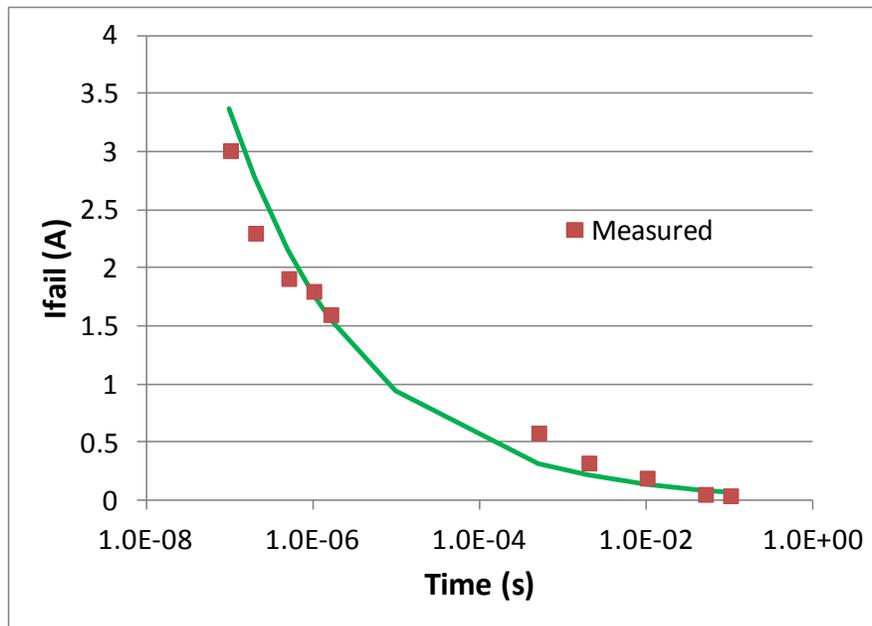
For better understanding, the failure current of a pin was measured as a function of pulse duration (see Figure 31). The data shows that the failure current is less than 100 mA for pulses longer than ~10 ms. The curve tracing on the ESD tester definitely used pulses in this time range. Thus it is possible that the DC curve trace damaged the devices.

Figure 31: Power Profile

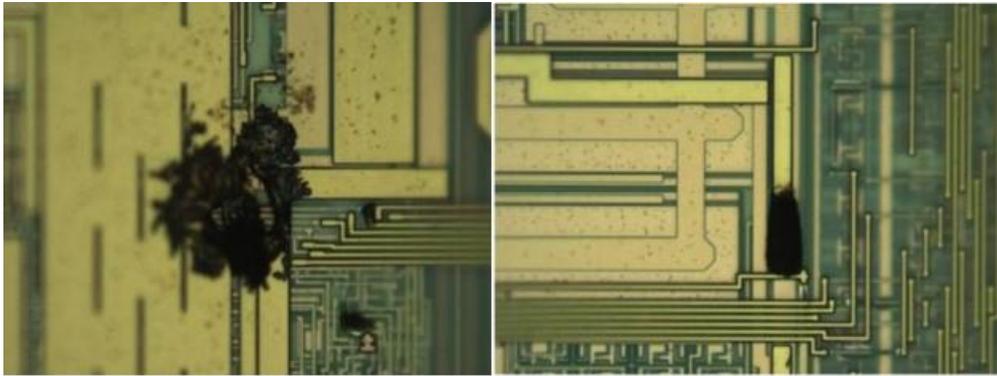
After physical analysis it was observed that the fails were related to the EIPD location as shown in Figure 32. A metal trace was damaged, leading to a short between the supply and a bus. This failure mode was not observed during the IC qualification or through other customer returns.

Figure 32: Optical Photo of Damaged Devices, Two Locations on the Same Track

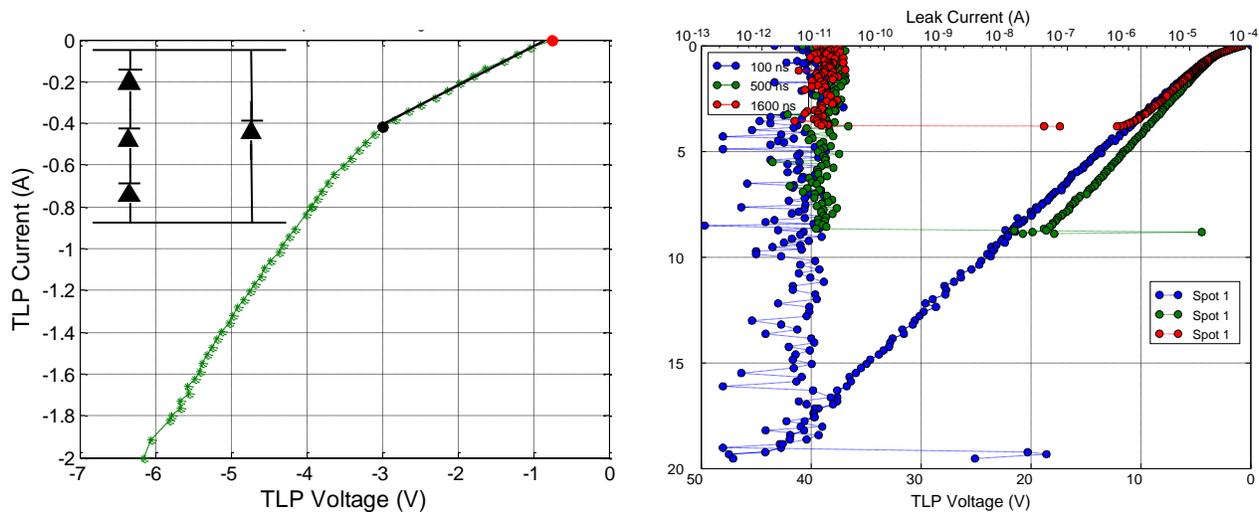
The device was characterized by TLP. For positive pulses, all pins were damaged at extreme voltages, which were unlikely to occur in the application. For negative pulses, the lowest failure levels were observed for the battery pin. Further characterization showed that the failure point decreased quite rapidly with increasing pulse duration, as illustrated in Figure 33. The circuit associated with the damage location basically consists of a single, relatively high ohmic diode, in parallel with 3 diodes in series. This explains the change of slope when the voltage gets below -3 V. The damage is in the single diode track. By separating the currents over these 2 branches the current required to damage the diode track can be extrapolated and subsequently the voltage required for damage can be plotted vs. pulse duration. The result is shown in Figure 34. From this it can be concluded that damage is possible at relatively small voltages if they are applied for sufficient amount of time. For example, at -3 V (the kink point), the expected life time is just a few tens of microseconds.

Figure 33: TLP Characteristics of Pin Associated With the Damage.

Note the significant reduction in the TLP fail voltage and current at pulse widths of 500 ns and 1600 ns as compared to the 100 ns pulse width.

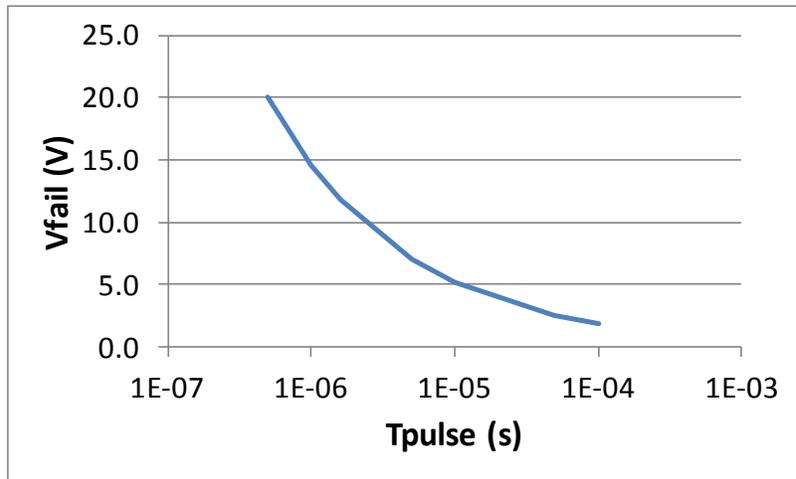
Figure 34: Calculated Failure Voltage Profile

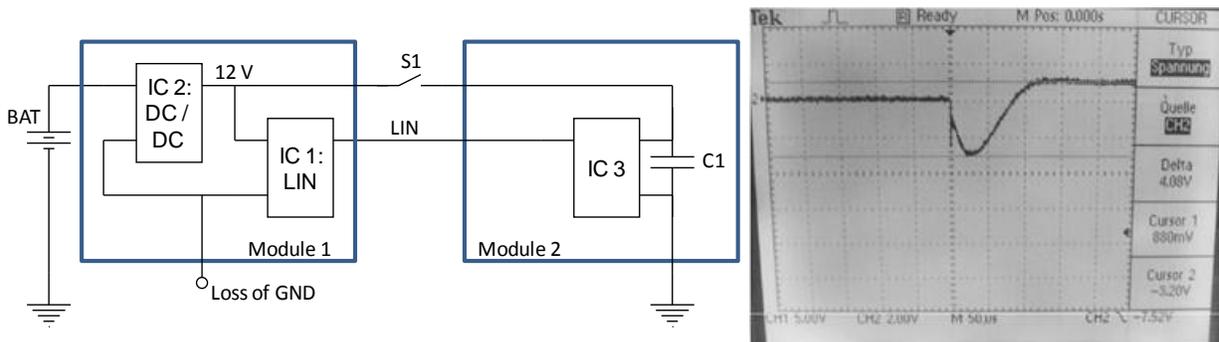
Figure 35 shows a simplified sketch of the application. When the switch S1 is closed the capacitor C1 needs to be charged. In a loss of ground situation for module 1 this causes a severe ground bounce. The test was done because the customer expected that a loss of ground could happen during the life time of the design. For example, this could happen during service or maintenance of the car, where this module would need to be temporarily removed or replaced. This is equivalent to a negative pulse on the supply of the IC. In-situ measurements during the test showed -6 V on the IC supply for ~100  $\mu$ s. As demonstrated above, this is sufficient to damage the IC. The datasheet specified an AMR of -0.5 V and the use of a series diode in the supply line to block reverse current.

Figure 35: Simplified Schematic (left) and Signal Leading to Damage (right)

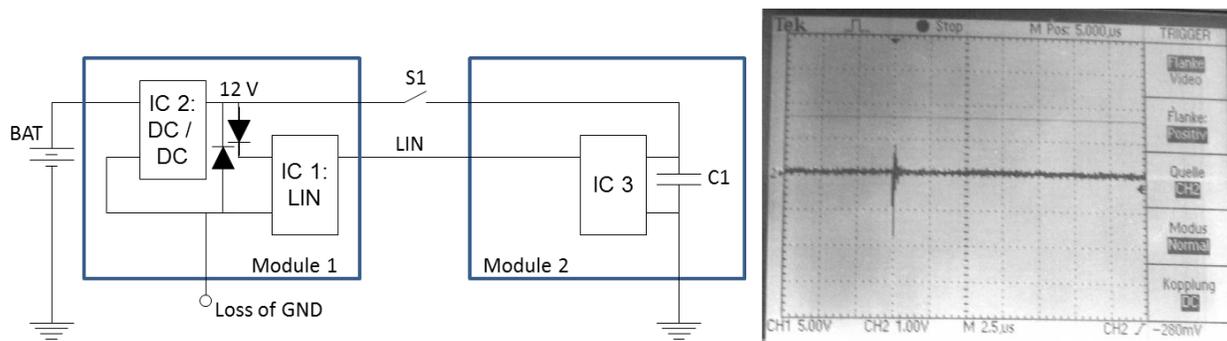
loss of ground could be possible during the life time of the design, practically speaking this could be consider a hot plugging event. In this case, the EOS damage was not a field return, but occurred during a customer qualification test to verify that the system was robust against such occurrences in the field. Therefore, the real root cause is the deliberate loss-of-ground.

Figure 36: Simplified Schematic of Solution (left) and Resulting Signal during Stress (right)

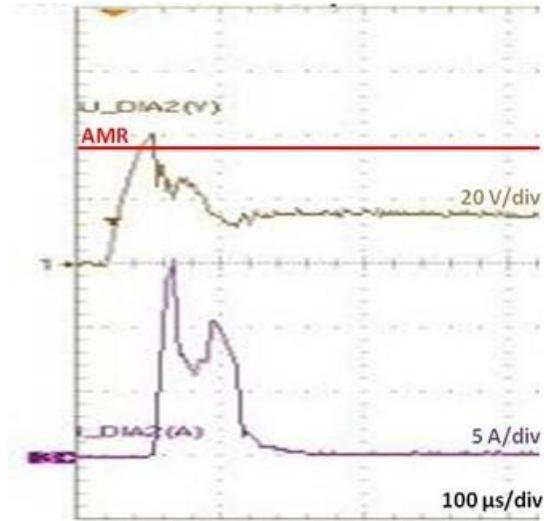
Figure 40: I/V Characteristics at LIN Bus Terminal – Creating Damage

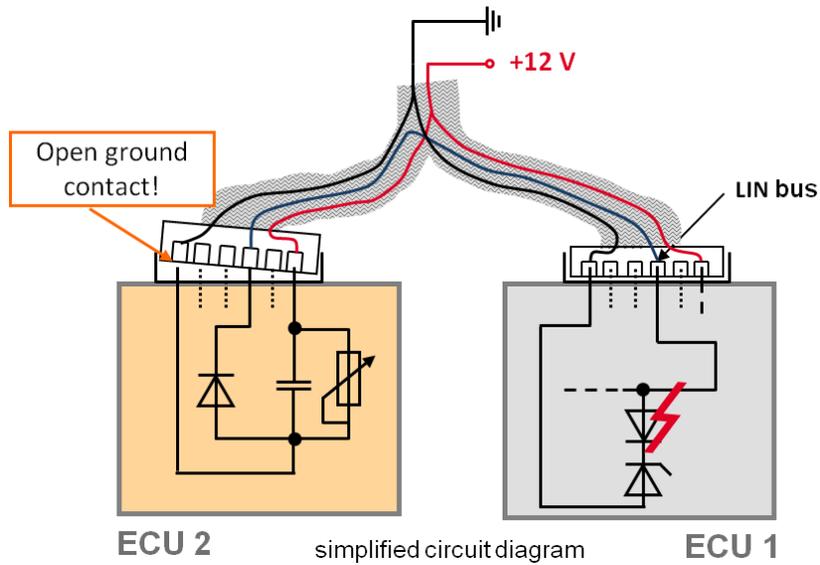
The connecting of ECU2 to the energized vehicle wiring system (hot plugging of ECU2) caused high voltage and current peaks on the LIN bus. One reason for this was the undefined contact sequence at the ECU plug during the plugging process (see Figures 43 and 44). Depending on the angle of the wiring harness connector during the plugging process, the supply voltage pin and other ECU pins could have been electrically connected while the ground connection was still open. This resulted in undefined voltage and current peaks on the LIN bus. The long (several meters) LIN bus wire, and consequently higher inductance, additionally increased the amplitudes of the voltage pulses.

Figure 43: Hot Plugging of ECU2; Mechanical Diagram

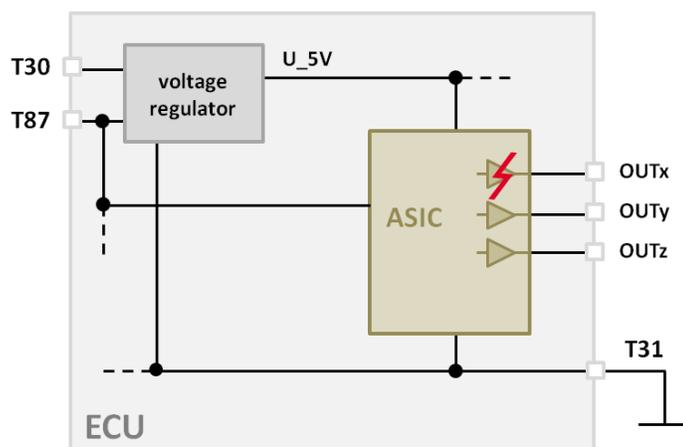
Figure 46: Simplified Circuit Diagram of ECU

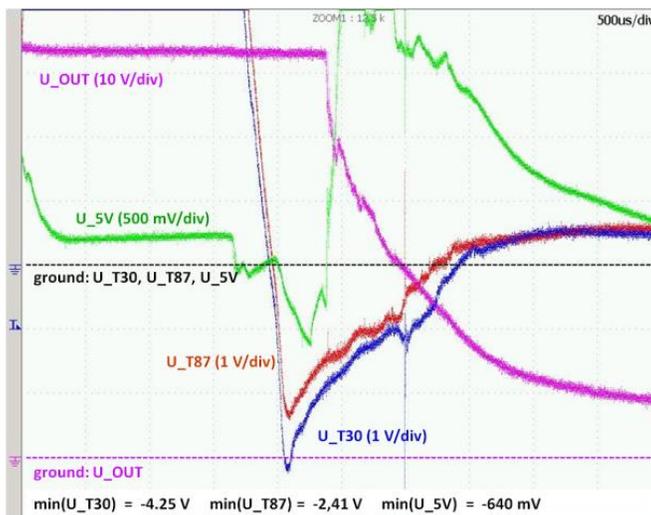
Figure 47: Critical Voltage Characteristics during Bouncing of Battery Ground Terminal

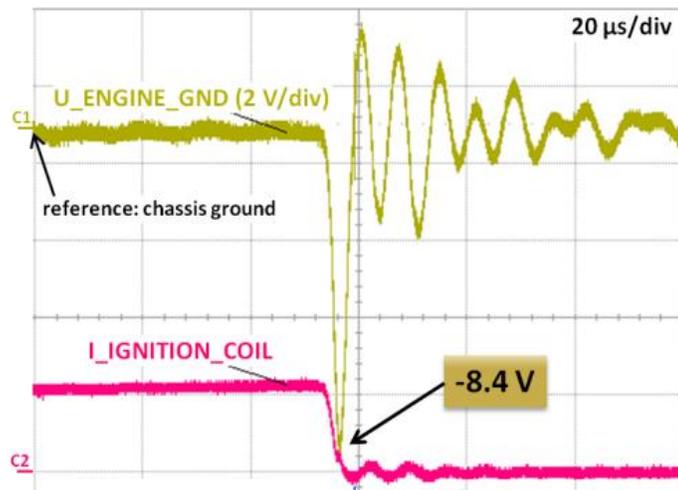
Figure 50: Ground Offset Caused by Switching Off the Current at the Primary Side of an Ignition Coil

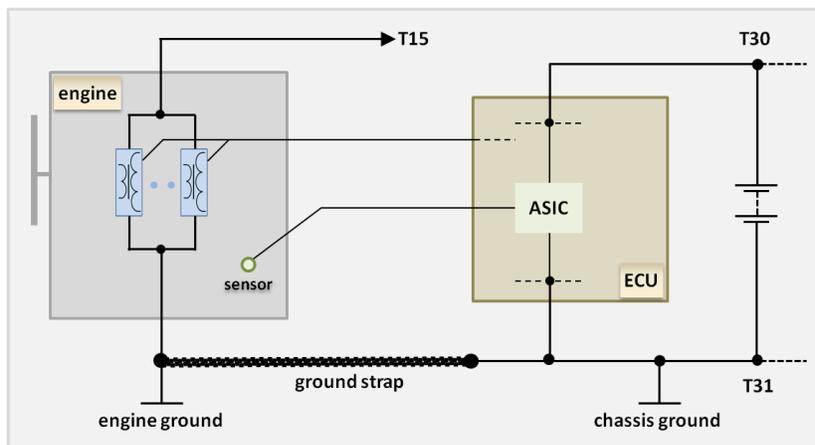
Figure 51: Schematic of Ground Wiring

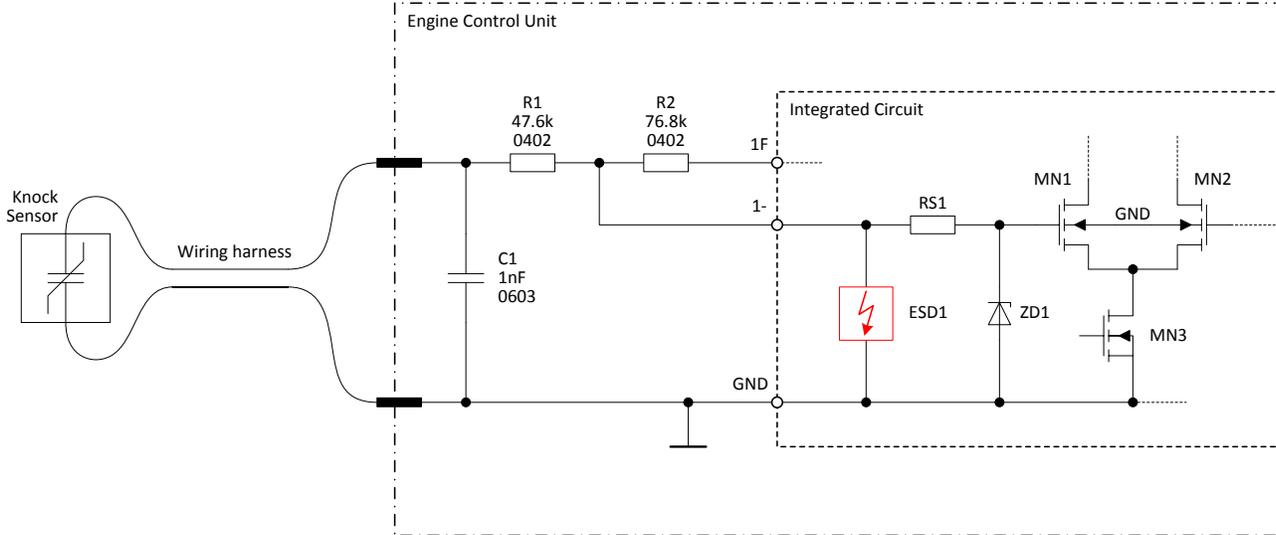
Figure 53: Simplified schematic of the knock sensor application. The damaged ESD protection element ESD1 in the IC is indicated in red.

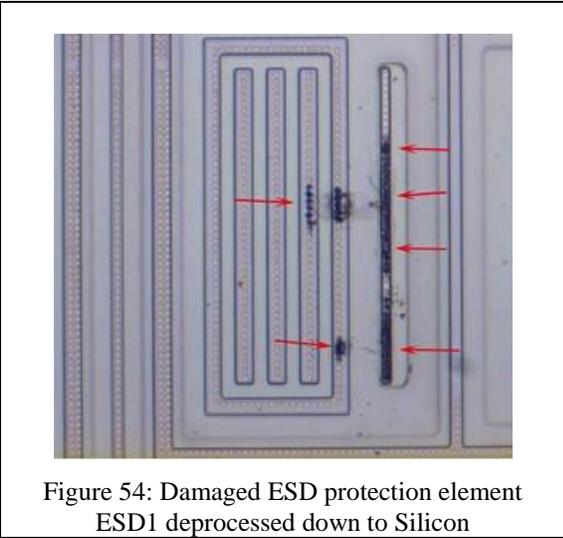
Figure 54: Damaged ESD protection element ESD1 deprocessed down to Silicon

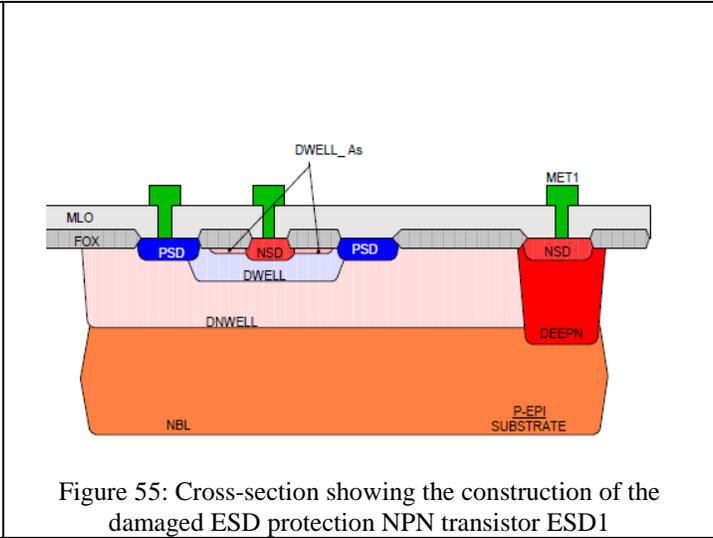
Figure 55: Cross-section showing the construction of the damaged ESD protection NPN transistor ESD1

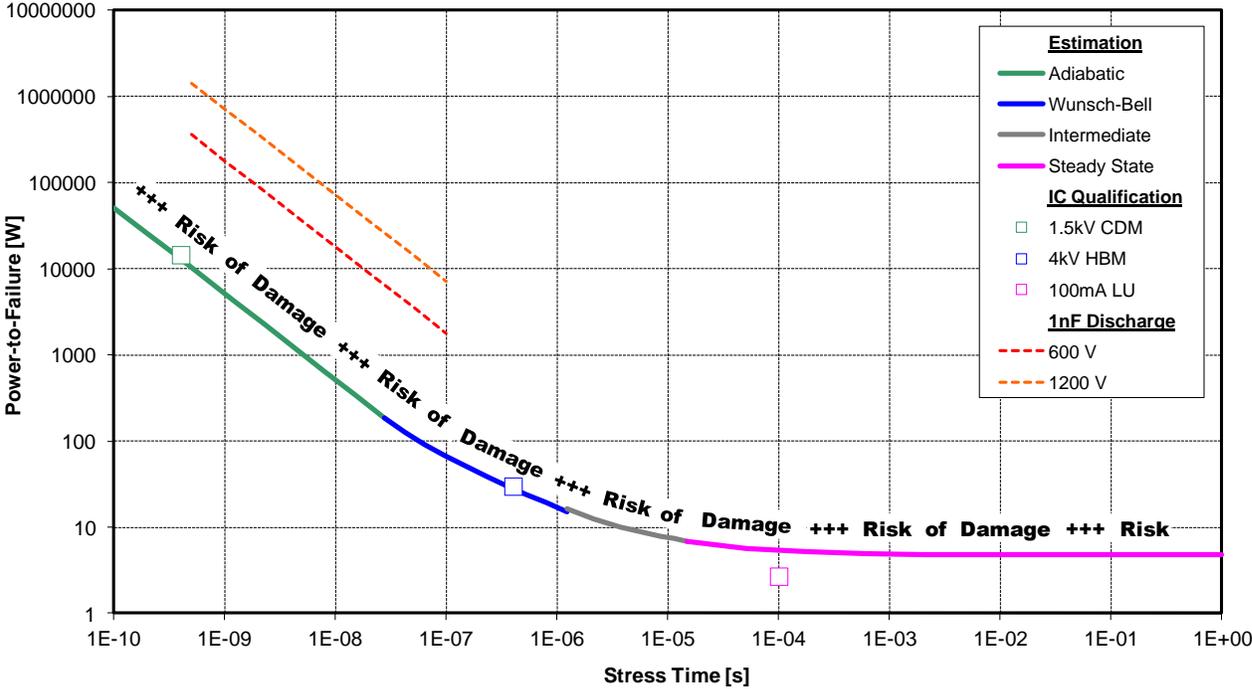
Figure 56: Power-to-failure data of the damaged ESD transistor ESD1: Estimated power-to-failure characteristic (solid line), dissipated powers at 1.5 kV CDM, 4 kV HBM and 100mA LU (marker symbols) and dissipated powers of a 600 V and 1200 V discharge of a 1nF capacitor into the ESD transistor (dashed lines).

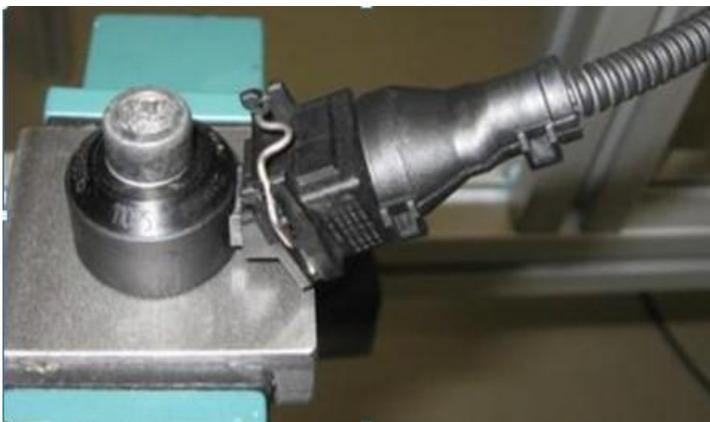
Figure 58: Photo of the knock sensor (on the left) and its connection to the wiring harness

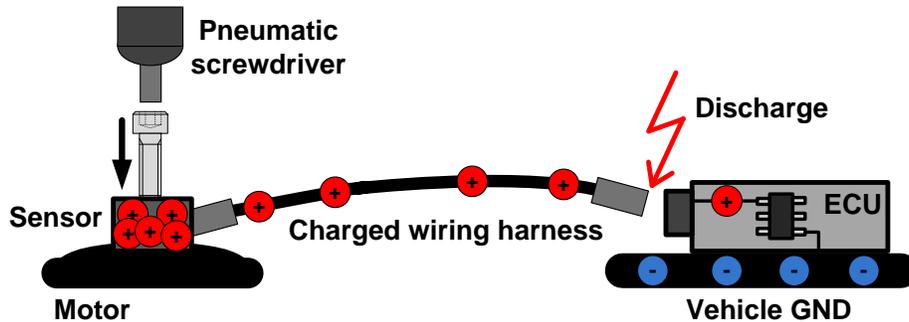
Figure 59: Discharge of the charged knock sensor and wiring harness into the ECU and its IC.

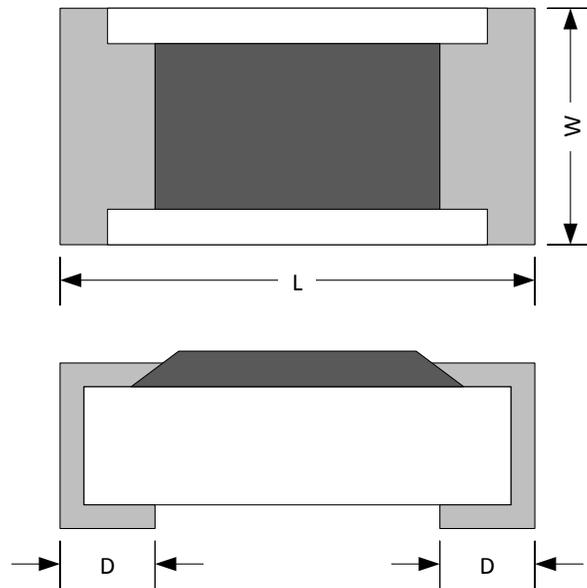
Figure 60: Top view and side view of the 0402 SMD resistor R1.

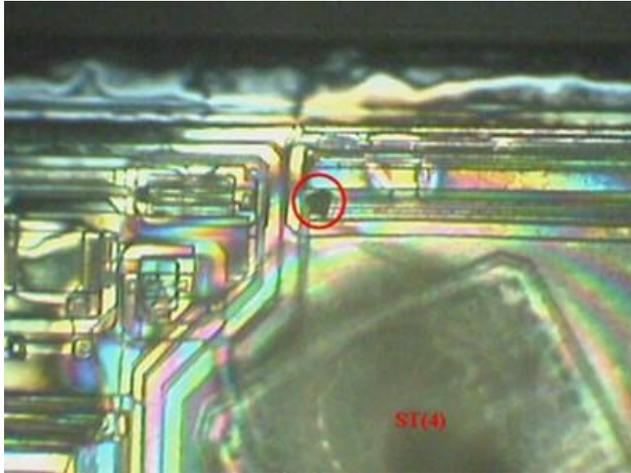
Figure 61: LCT Spot View in the Corner of ESD Diode.

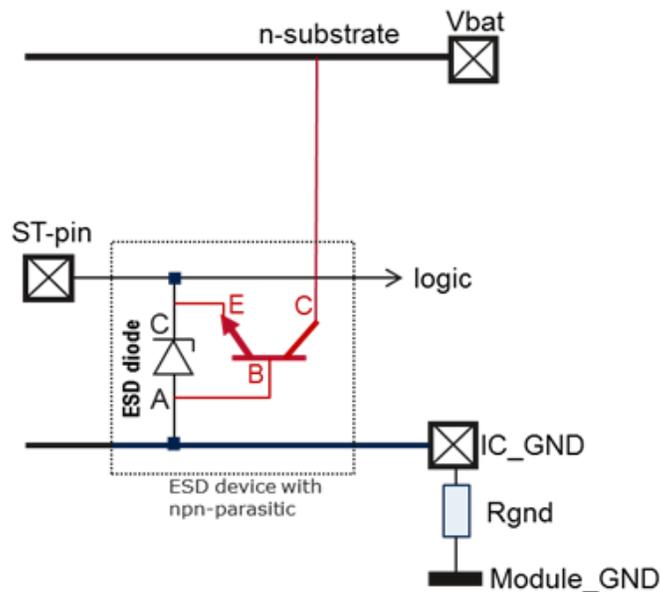
Figure 63: Parasitic NPN Connection off of the ESD Diode

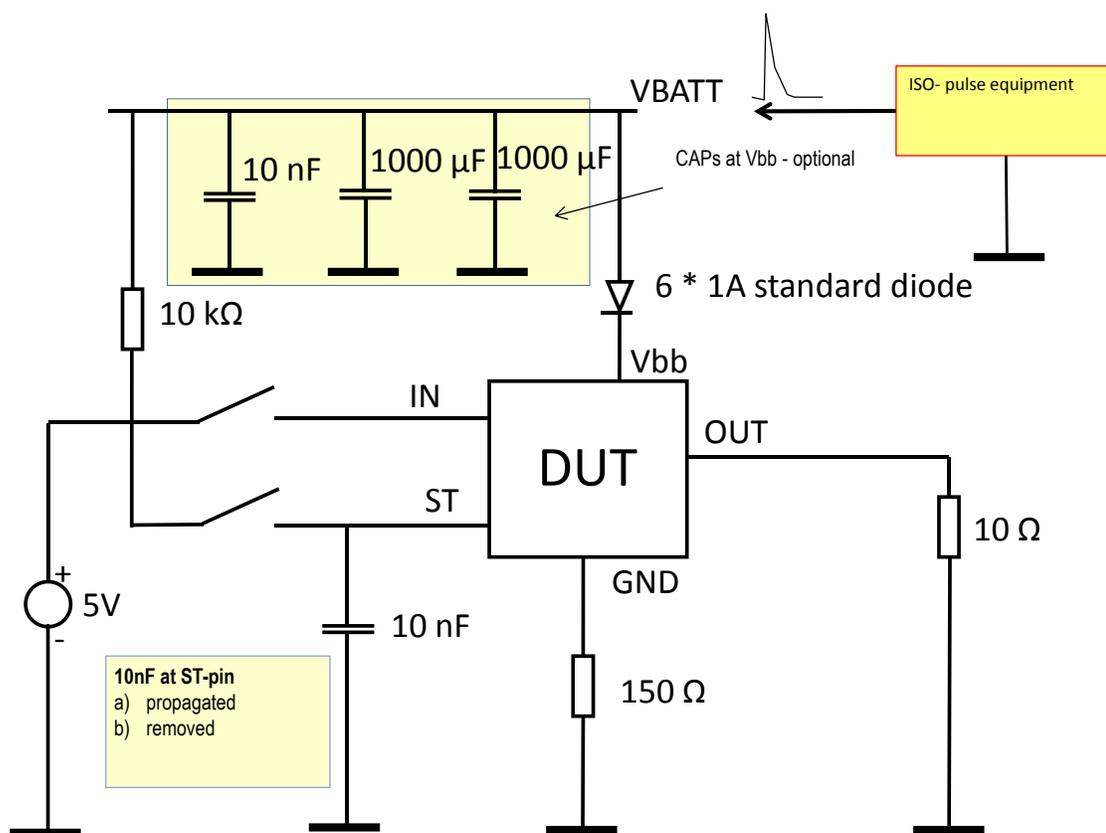
Figure 64: Schematic of Test Setup with an Application-like Board

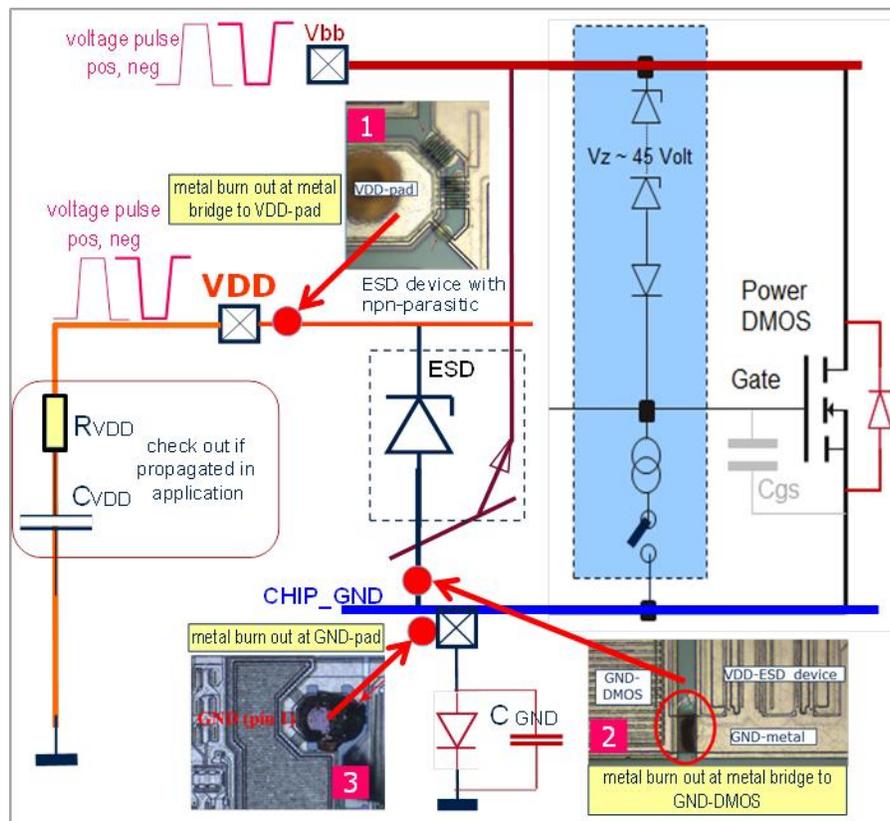
Figure 68: Schematic of the Damage Locations

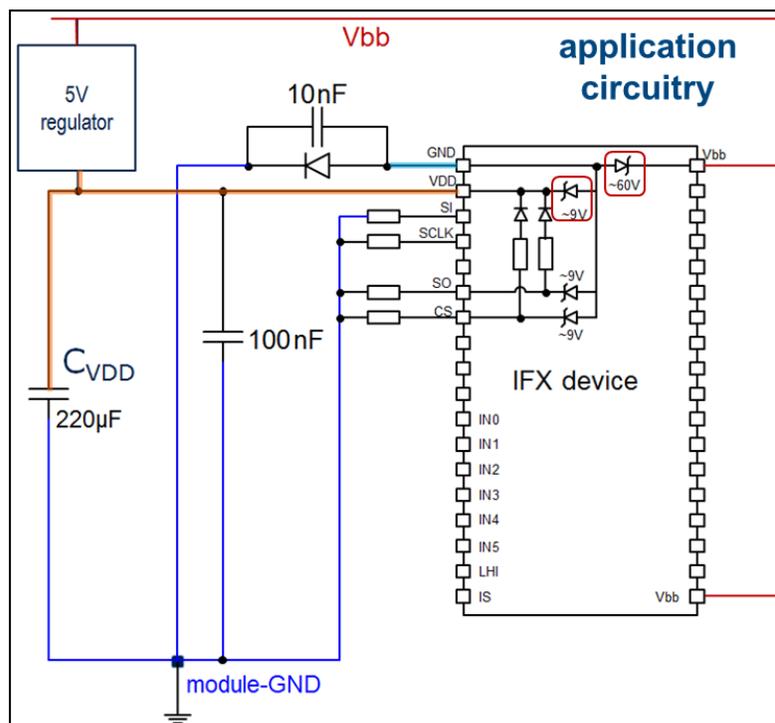
Figure 69: Customer Application

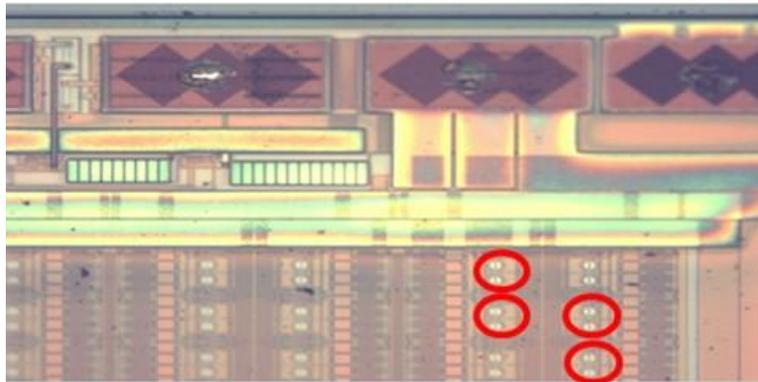
Figure 70: Random Fuse Block Failures in an Accelerometer IC

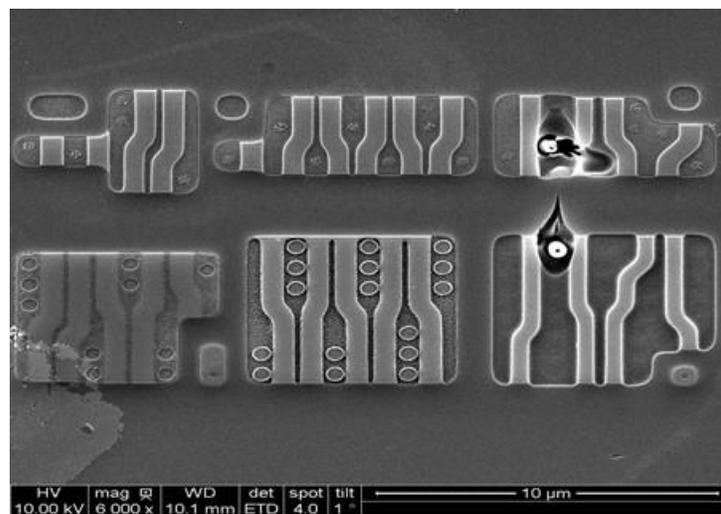
Figure 71: NMOS / PMOS Latch-up Failure in an Isolated Logic Block of an Accelerator IC

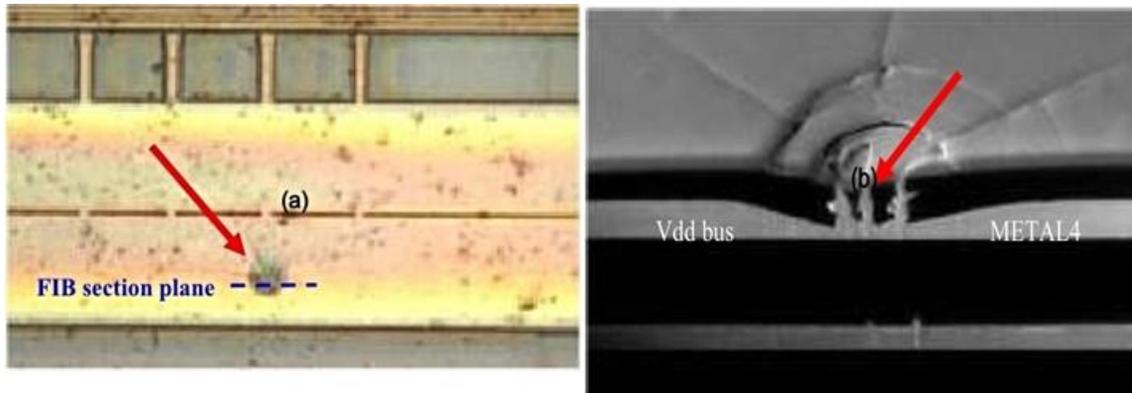
Figures 73 (left) and 74 (right): Optical (left photo) and corresponding focused ion beam (FIB) cross-section image (right photo) of the melted / reflowed METAL4 AlCu “fingers” (see arrow) and overlying cracked passivation on a customer DSP board failure.

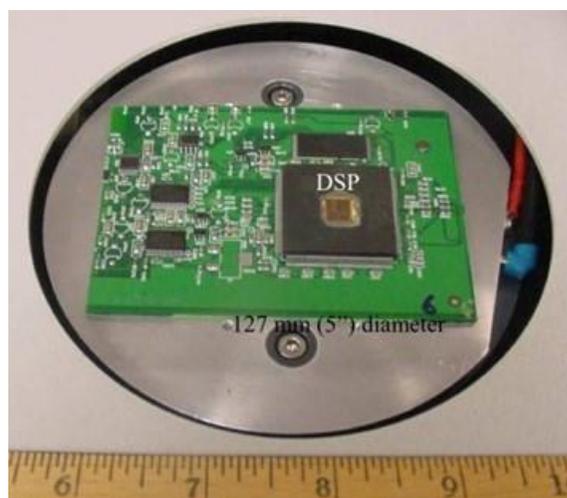
Figure 75: FICBE test method setup for the cut-down customer production board with the decapsulated DSP. The cuts were made along the top and left side of the PCB. Note that the DSP is located near the original corner of the PCB.

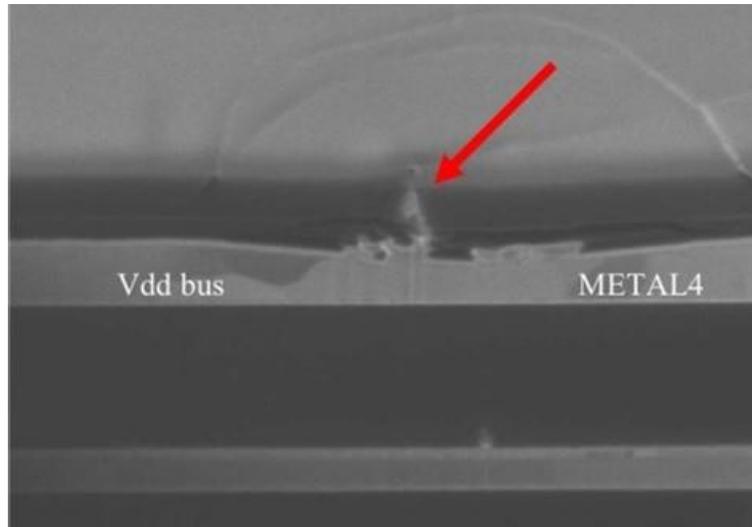
Figure 76: FIB cross-section image of the melted and reflowed METAL4 AlCu (see arrow) and cracked glassivation on a DSP IC stressed at -250V CBE using the setup in Figure 75.

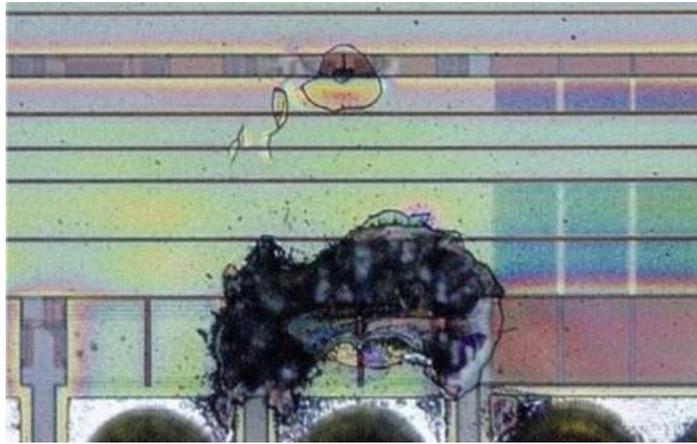
Figure 77: Typical catastrophic DSP damage observed along the supply buses and adjacent bond pads after stressing the cut-down customer boards at the CBE fail voltages listed in Table 6. Note the large areas of melted AlCu and missing passivation above this damage.
