# White Paper 4

## Understanding Electrical Overstress - EOS

### Industry Council on ESD Target Levels

Revision 1.0

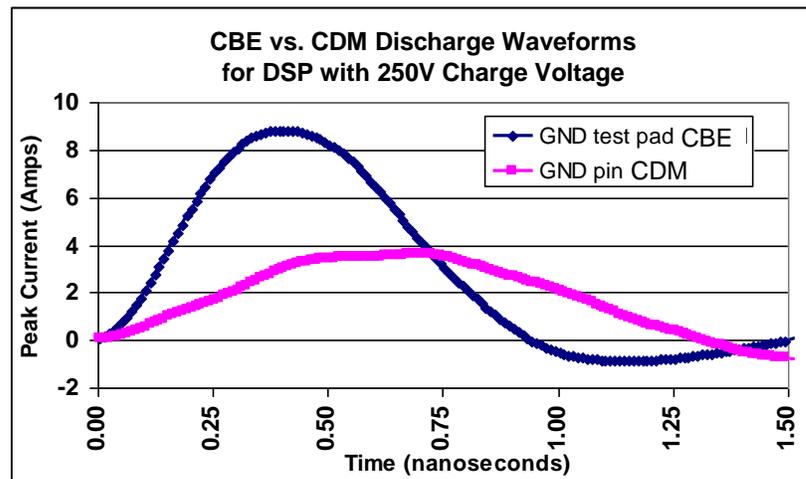
Figure 78: Comparison of 250 V FICBE and FICDM discharge waveforms at a DSP ground pad and pin depicting the higher energy in the CBE event for the cut-down PCB shown in Figure 75.

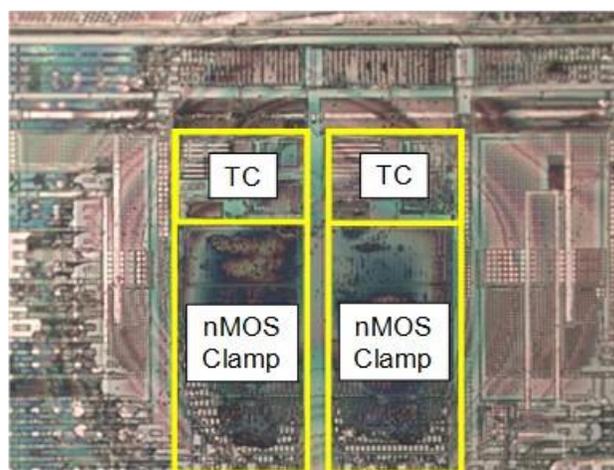
Figure 79: Photo of EOS Damage in 5 V ESD Clamps after BI

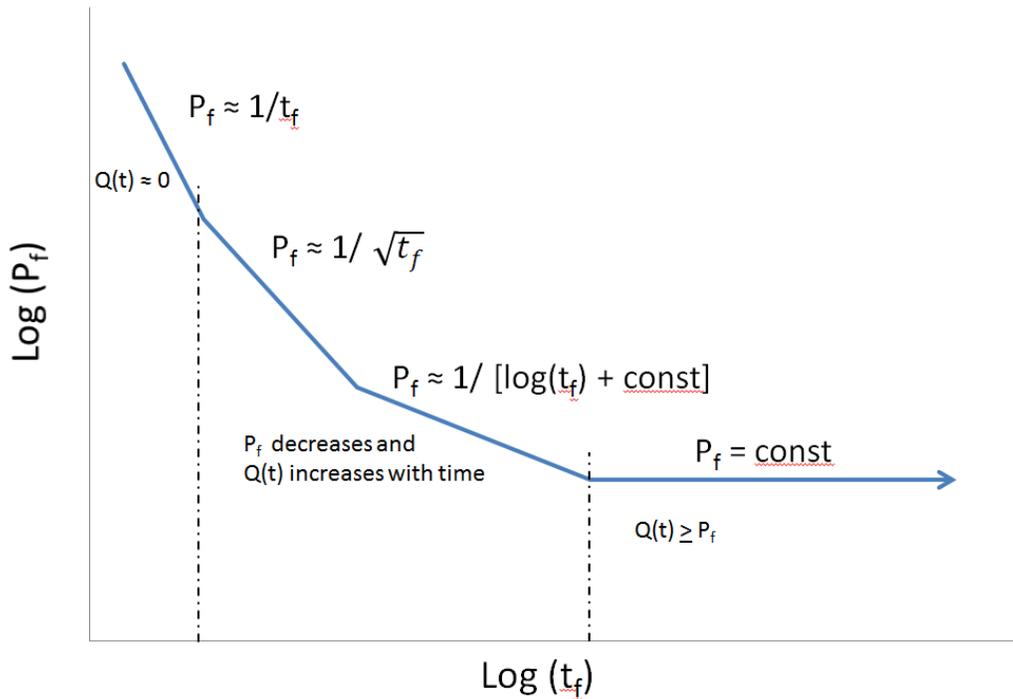
Figure 83: Example Power to Failure Curve

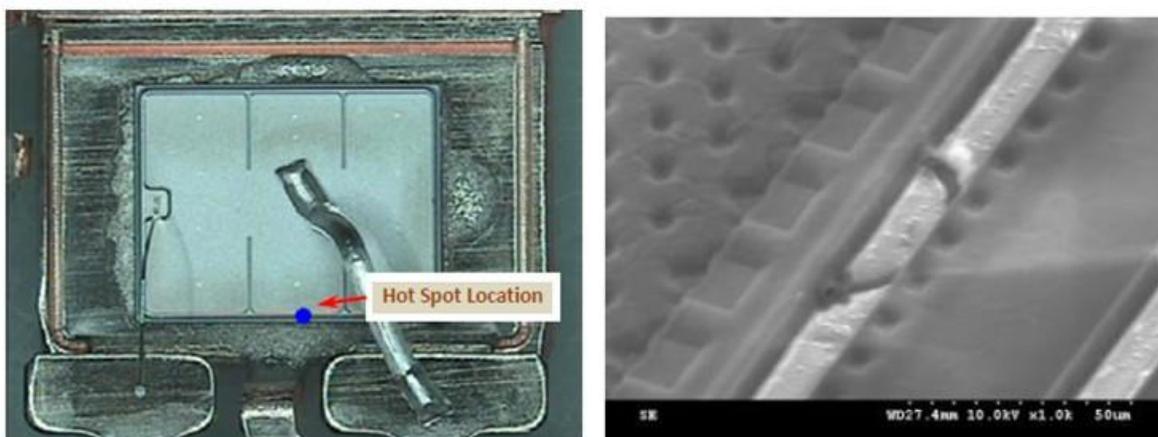
Figure 84: Hot Spot on Failing Device (left) and Corresponding SEM Picture (right)

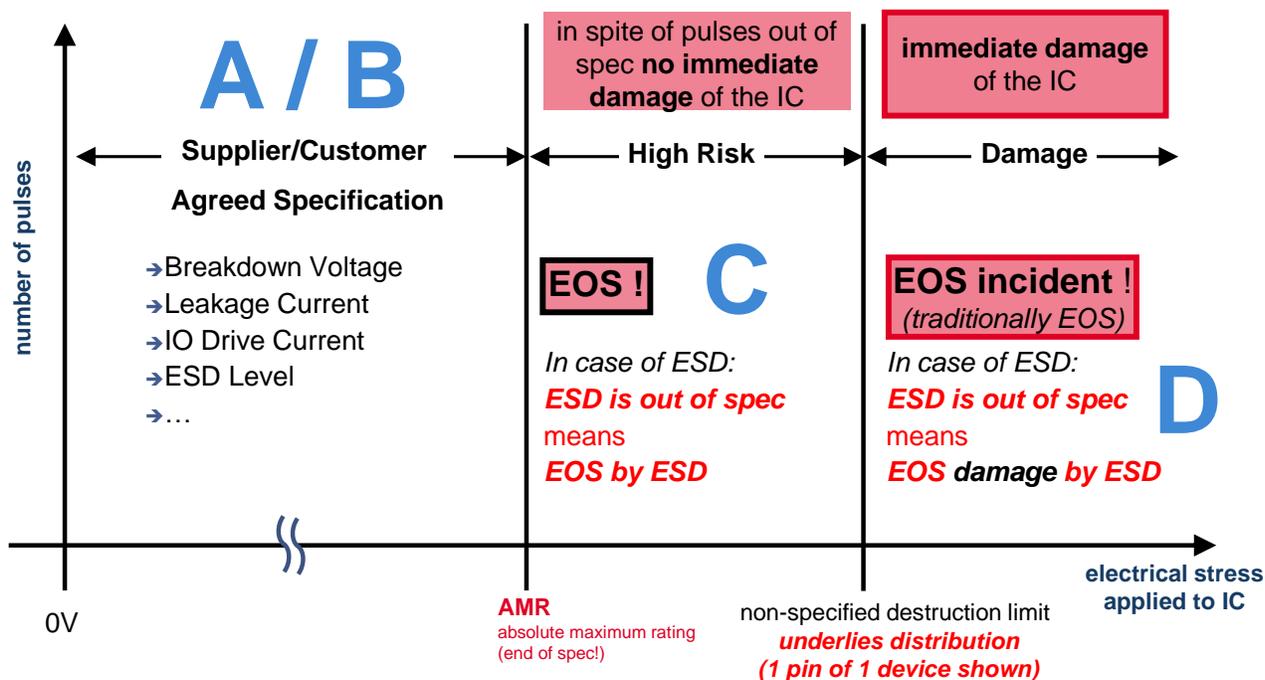
Figure 86: EOS Example Using ESD Leveraging the General Figure 21 of Chapter 3, Note: Sharp Transition between Region C and D due to Depiction of 1 pin of 1 device (no distribution)

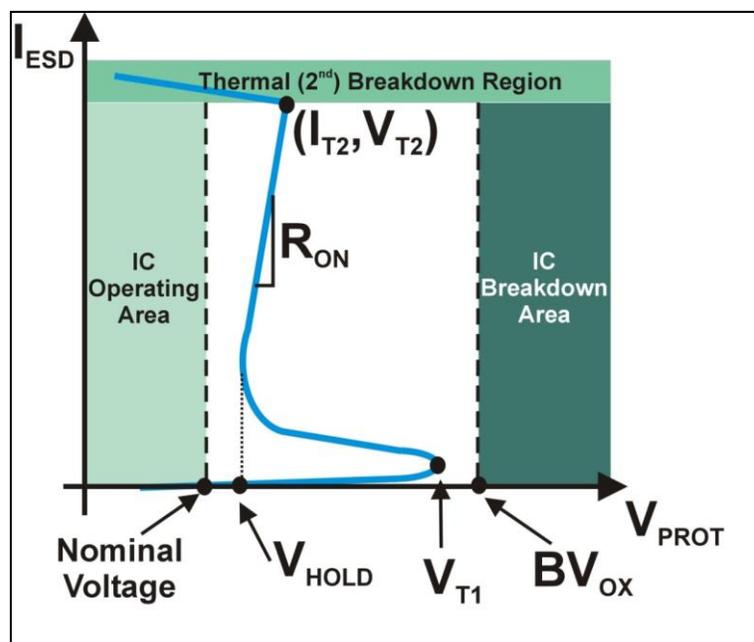
Figure 87: The ESD Design Window

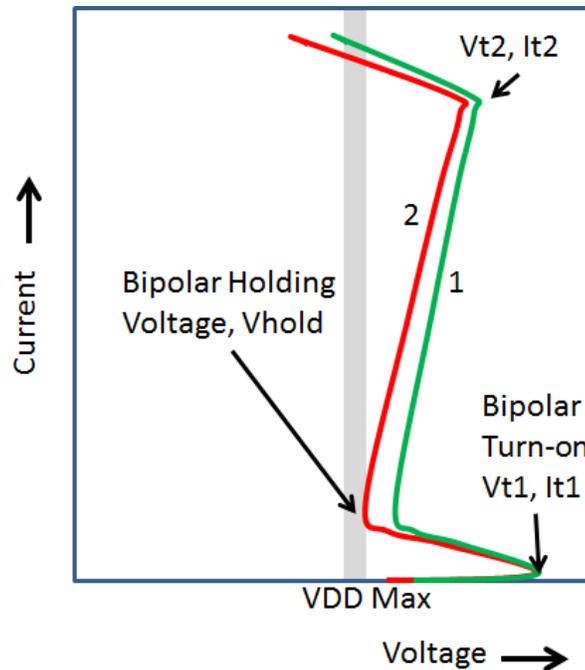
Figure 88: Characteristics of a Snapback ESD Protection Device

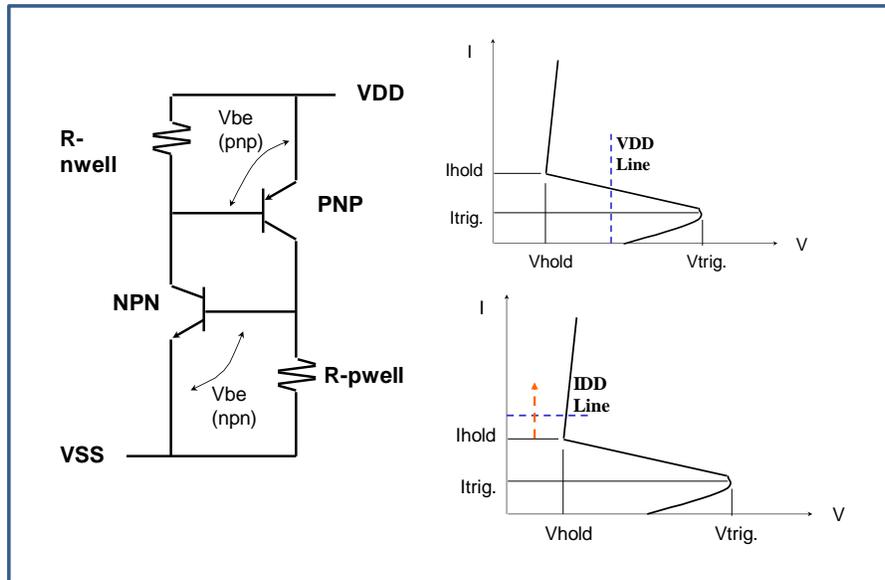
Figure 89: SCR Protection Device and ESD Characteristics

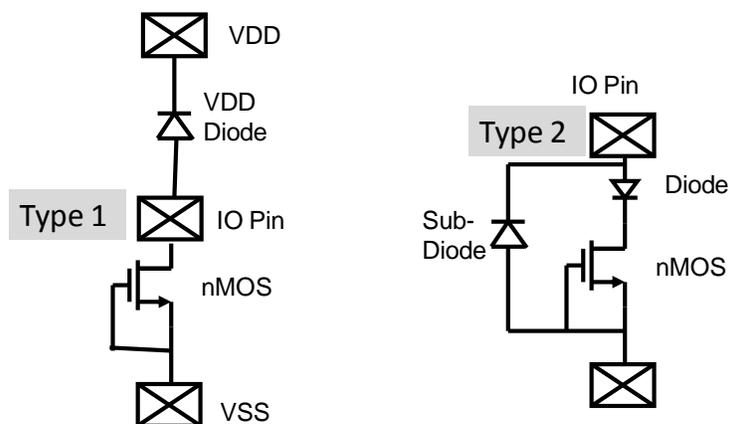
Figure 90: Design of Substrate Triggered Protection Devices

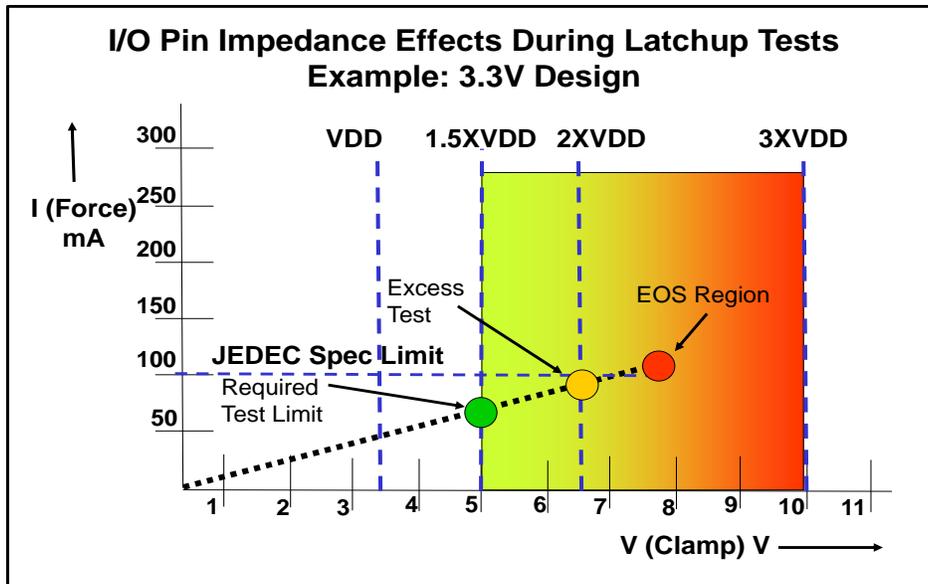
Figure 94: Example of EOS risk in JEDEC Latch-up Testing

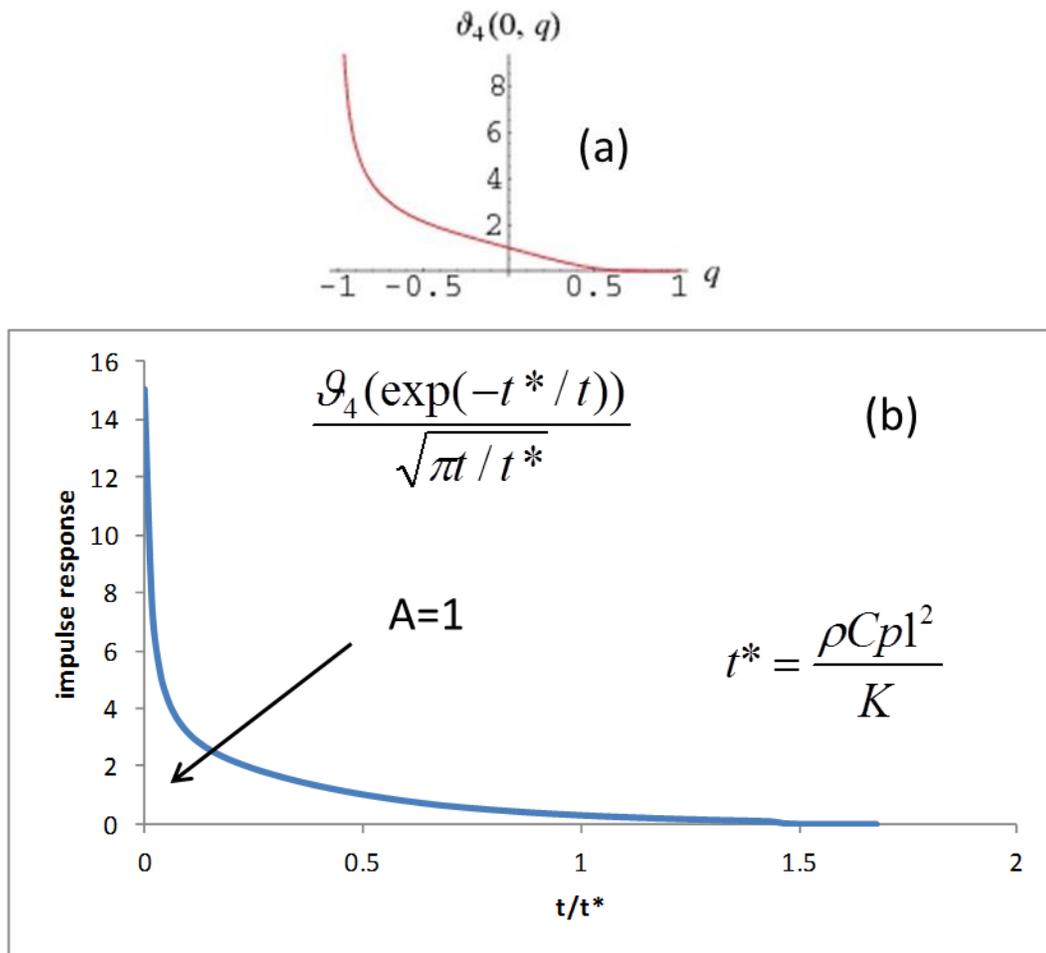
Figure B2: (a) Plot of Jacobi Theta4 ( $\vartheta_4$ ) function [13]. (b) Normalized impulse response from  $Z(t)$  of shorted t-line, Eq. (6).

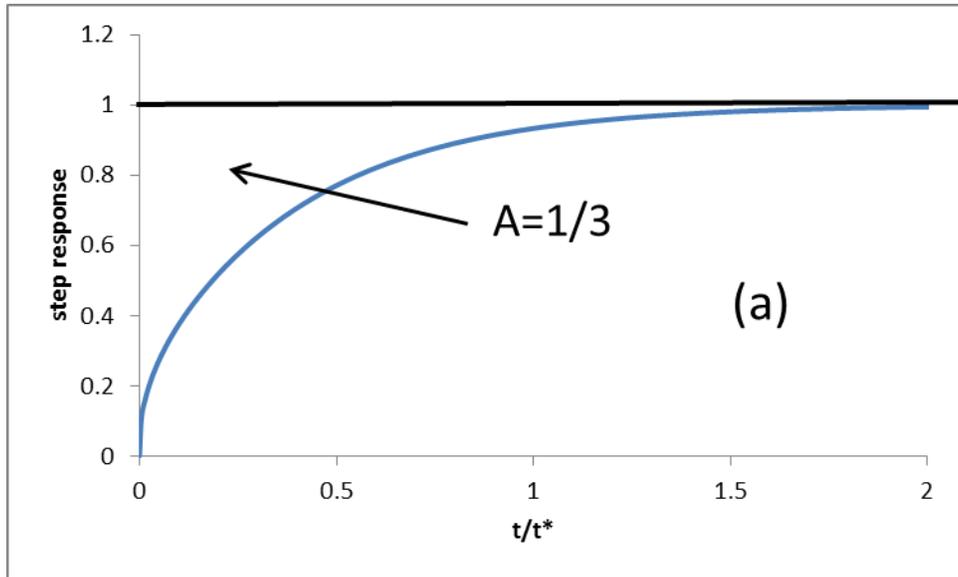
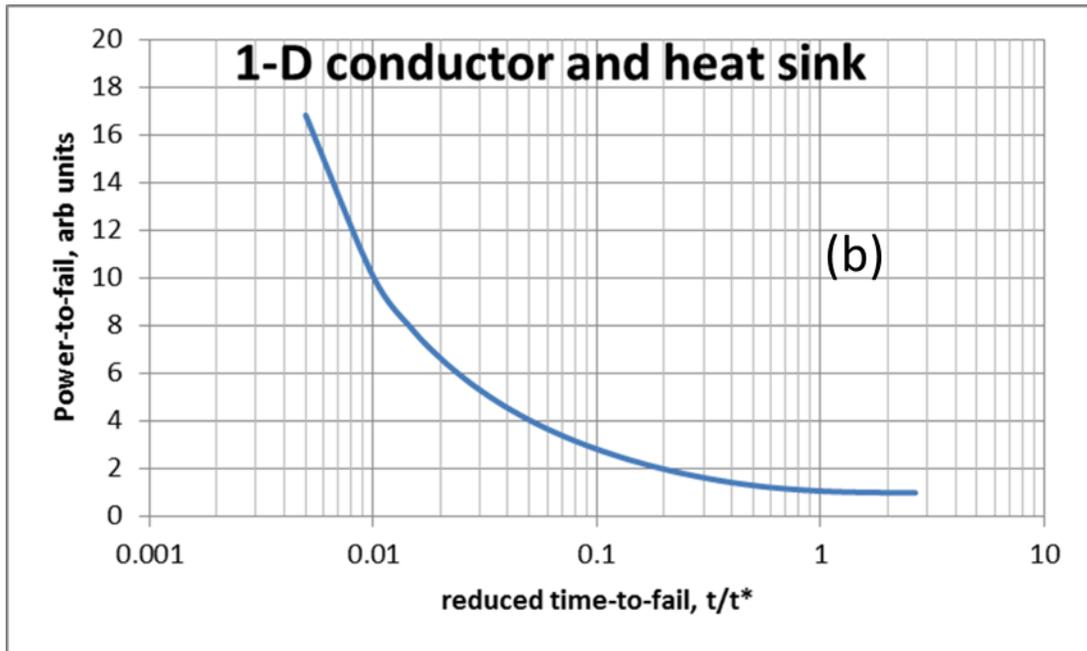
Figure B3: (a) Integrated normalized  $Z(t)$  (step response) from Figure B2b, showing convergence to 1 and Elmore Delay [15] of  $t^*/3$ . (b) Semilog plot of Normalized Dwyer Curve based on 1D Heat Flow Model of Figure B1.

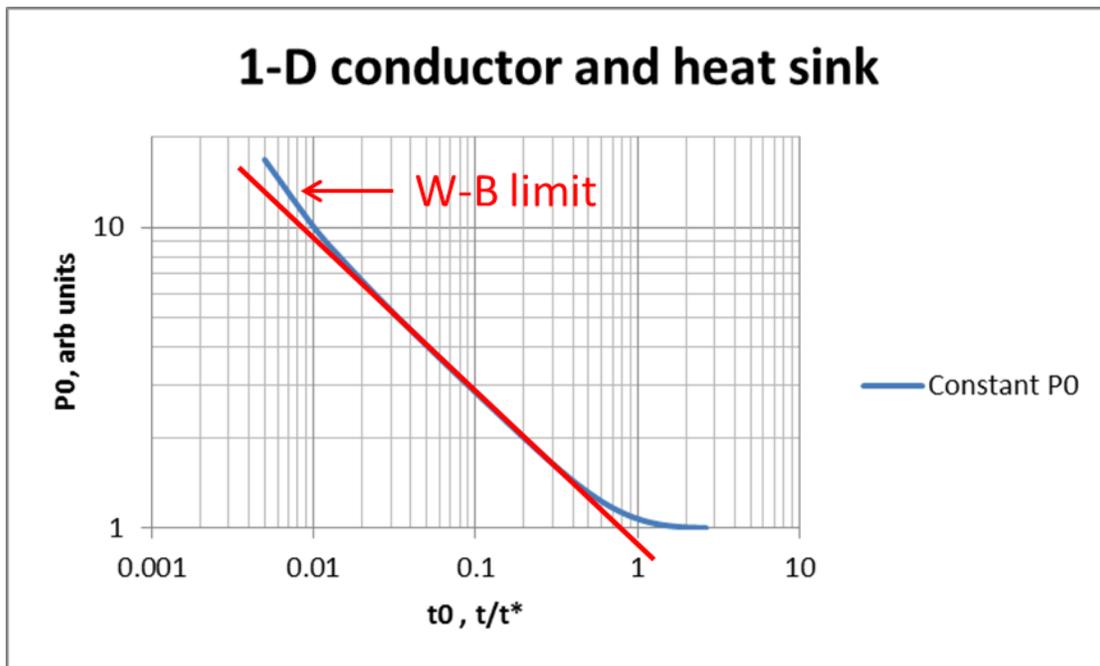
Figure B4: Log-log plot of normalized Dwyer curve, or Eq. (9), showing power law in the mid-section, extrapolated to  $t=0.79t^*$ . This is how to extract a characteristic time  $t^*$  from plotted data.

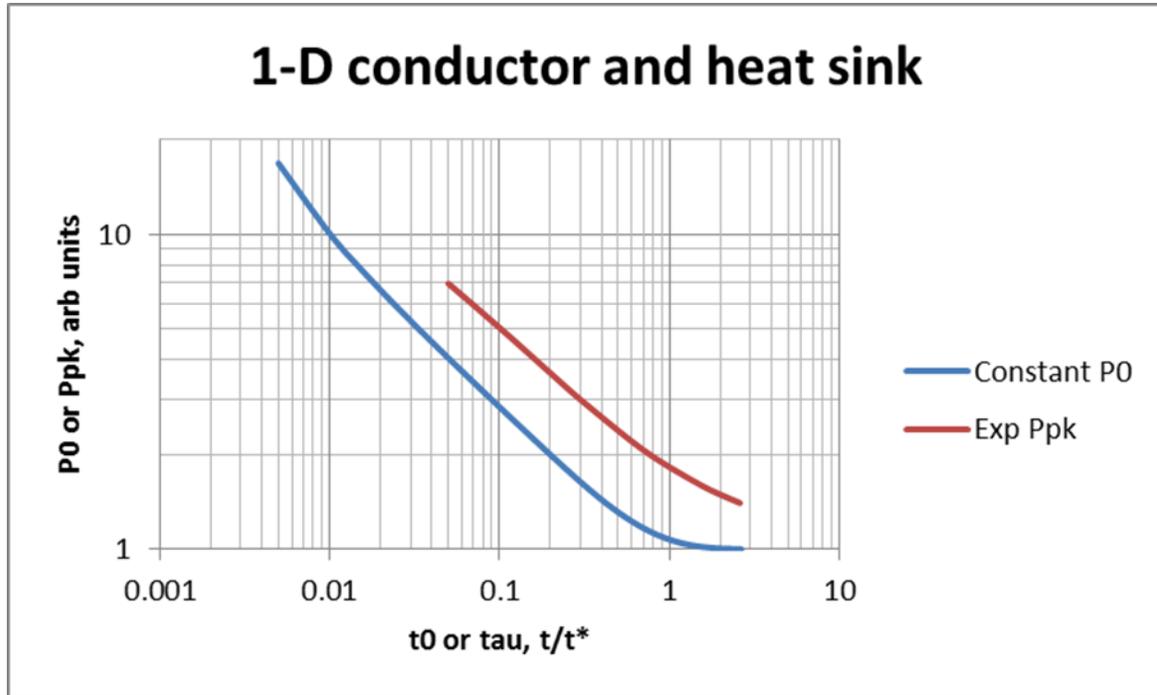
Figure B5. Constant power  $P_0$  Dwyer curve (blue) vs. pulse length  $t_0$  compared with peak power  $P_{pk}$  exponential curve (red) vs. time constant  $\tau$ , normalized to  $t^*$ . Exponential curve calculated from convolution with  $Z(t)$  as in Eq. (6) and over most of its range is about  $2x_0=1.848\dots$  above the constant power curve as predicted by the Dawson integral.
